Manhole Inspection Summary

Manhole # S17SS_006MH

Location Address: **2306 TIOGA PARKWAY**

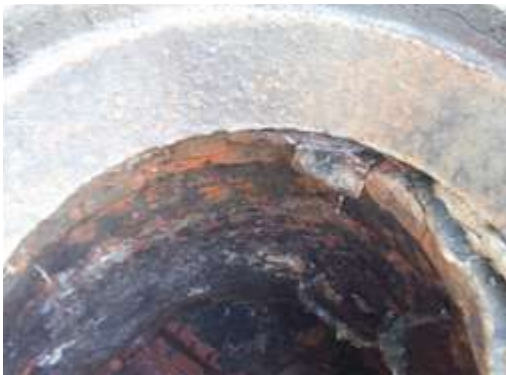
Defect 2

Condition: ☐ Sound ☐ Cracked ☐ Root Intrusion ☒ **Loose Brick** ☒ **Deteriorated**

CHIMNEY LOOSE BRICKS

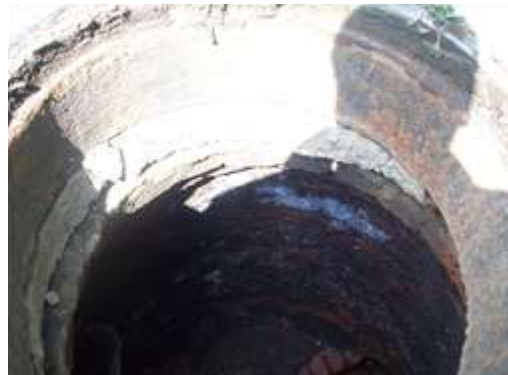
Defect 1

CHIMNEY DETERIORATED

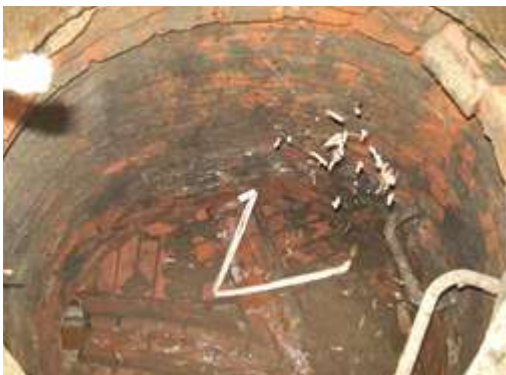
Defect 4

Steps Count: **2** Missing: **0** ☒ **Corroded**

Surcharge ☒ **Evidence Of Surcharge** Depth: **4** (ft.) ☐ Active Surcharge Present

EVIDENCE OF ASUR AND CORRODED STEPS

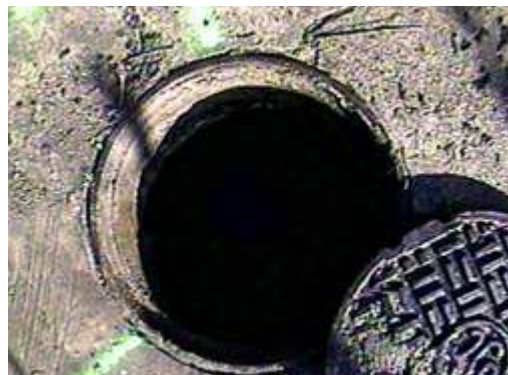
Defect 3

Frame Offset: **2** (in.) Condition: ☒ Sound ☐ Cracked ☐ Leaks

FRAME OFFSET

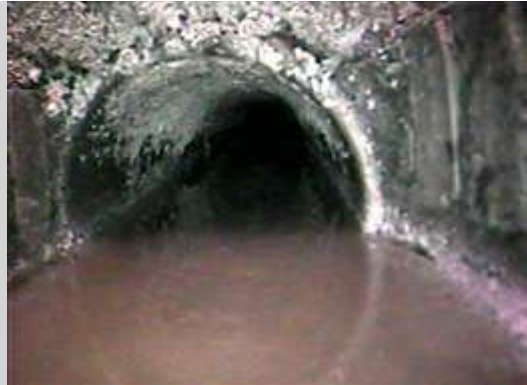
12 O'Clock Outflow

8 in. Circular Gravity Sewer
Pipe Out @ 12 O'Clock

Pipe Height: (in.) Direct
Pipe Material: **Clay** ☐ Pipe Lined
Invert Depth: **5.50** (ft.) Flow Characteristics: **Slow**
Deposits: ☒ None ☐ Mud ☐ Sludge ☐ Debris ☐ Grease
Silt Depth: (in.) Deposits Extent:
Infiltration: **None** Pipe Seal Cond: **Sound**

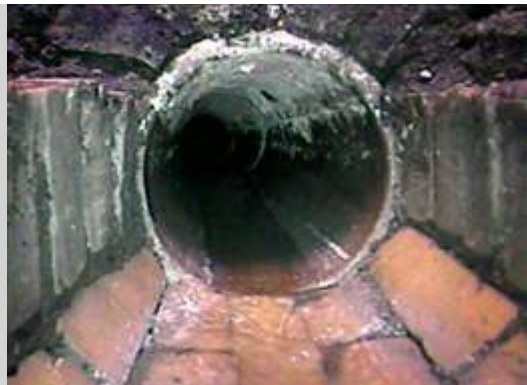
5 O'Clock Inflow

8 in. Circular Gravity Sewer
Pipe In @ 5 O'Clock

Pipe Height: (in.) Direct
Pipe Material: **Clay** ☐ Pipe Lined
Invert Depth: **5.42** (ft.) Flow Characteristics: **Slow**
Deposits: ☒ None ☐ Mud ☐ Sludge ☐ Debris ☐ Grease
Silt Depth: (in.) Deposits Extent:
Infiltration: **None** Pipe Seal Cond: **Sound**

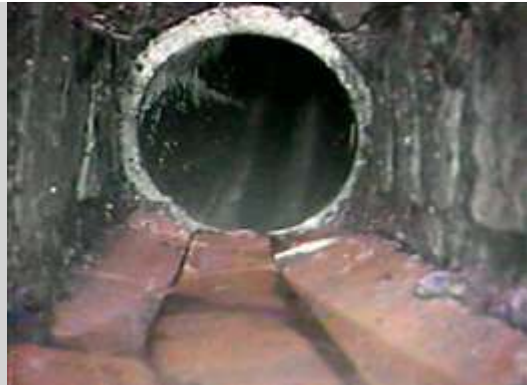
8 O'Clock Inflow

6 in. Circular Gravity Sewer
Pipe In @ 8 O'Clock

Invert Depth: **5.35** (ft.) Flow Characteristics: **Slow**

Infiltration: **None**

Pipe Seal Cond: **Sound**
